INGLESHAM CHURCH

ST. JOHN THE BAPTIST, INGLESAM, WILTSHIRE

Client: The Churches Conservation Trust
Contractors: Various
Date: 1988 - 1998

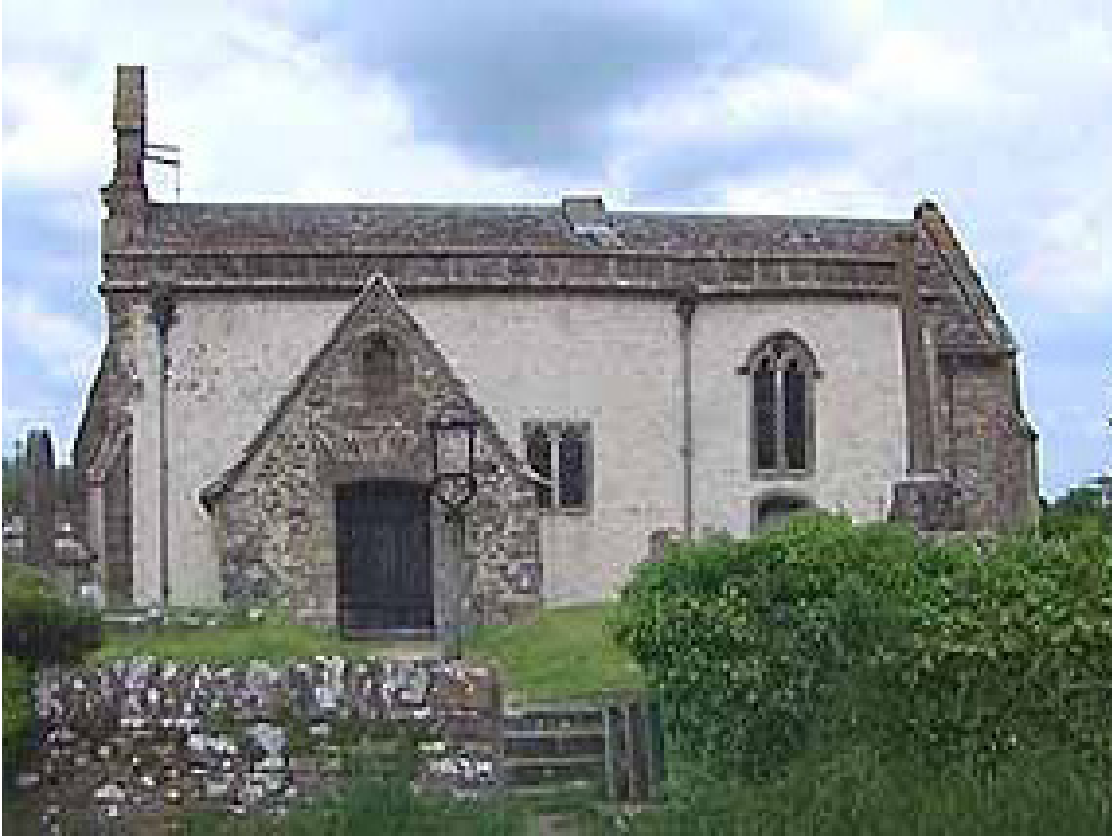
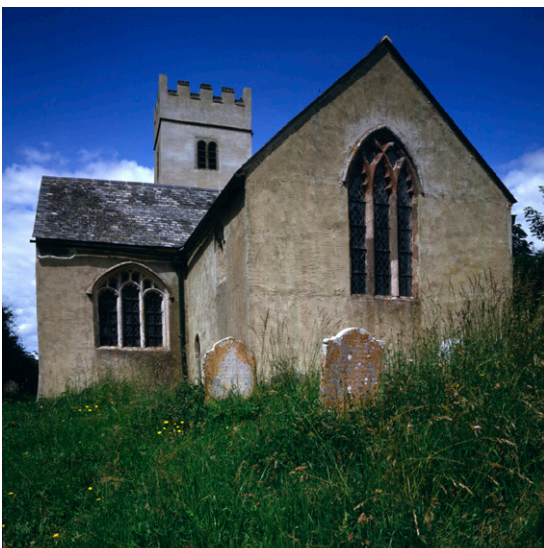
4 Inglesham is a medieval church. It was an early SPAB case on which William Morris worked.

Thorough phases of repair have been achieved which were highly complex to retain the original fabric as found. It involved wall painting conservation, stone tiled roofs, structural tying, conservation, masonry repairs, and ground drainage.

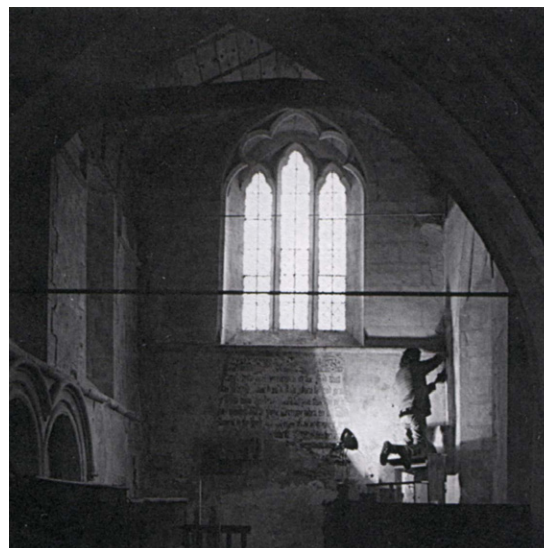
5 Repairs were kept to an absolute minimum. They were intricate and gentle to leave the building as found.

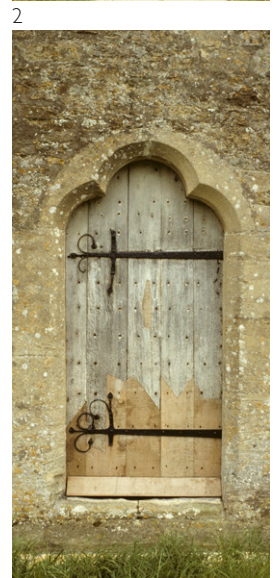
7
1 Inglesham Church
2 South porch
3 Repaired north door
4 East end
5 Chancel
6 17thc glass
7 Medieval wall painting
